Emerson Park

Sidewalk Conditions

Emerson Park Neighborhood Revitalization Plan

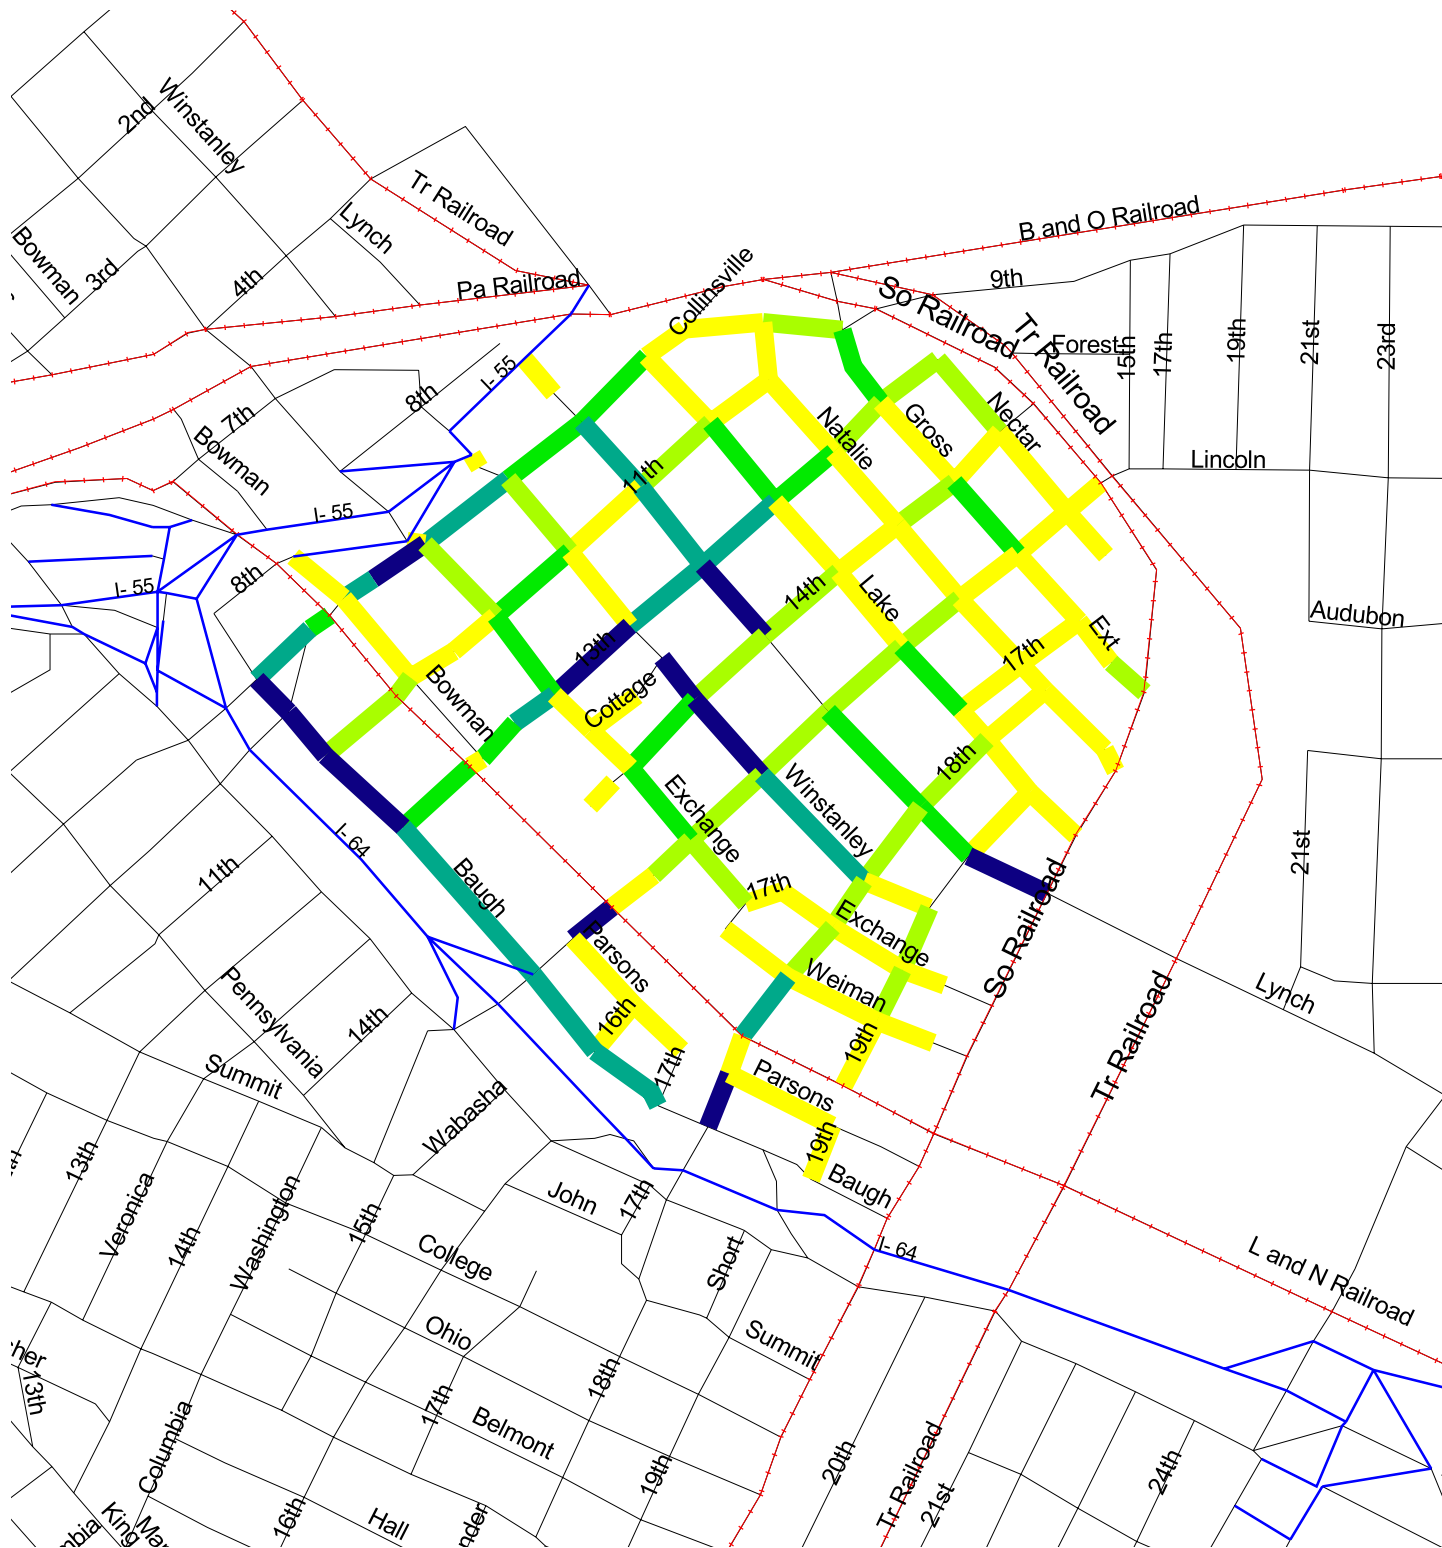
-   **Good**
Clean, level and no cracks or weeds.
-   **Fair**
Few small cracks and weeds.
-   **Poor**
Large cracks, a few missing sections and weeds.
-   **Deteriorated**
Many missing sections, overgrown with weeds.
-   **Destroyed or No Sidewalk**
No sidewalk or surface is completely destroyed.
